09-06-2016

Prepared For: John Jackals

Inventory of specific Trees: 2573 13th Ave W, Seattle, WA 98119

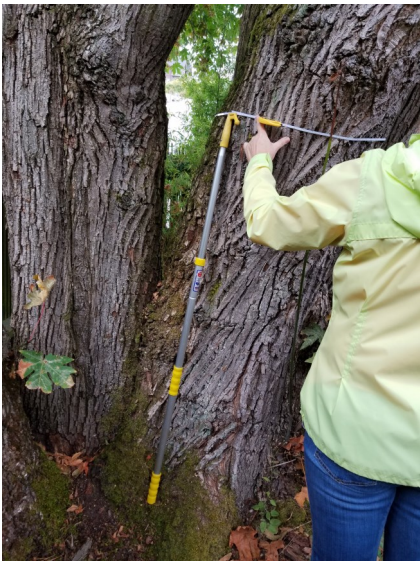
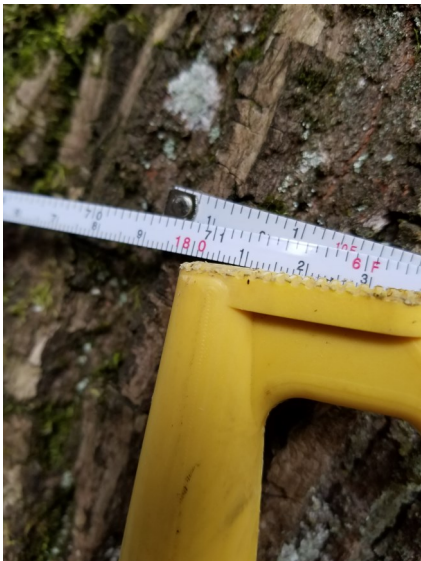
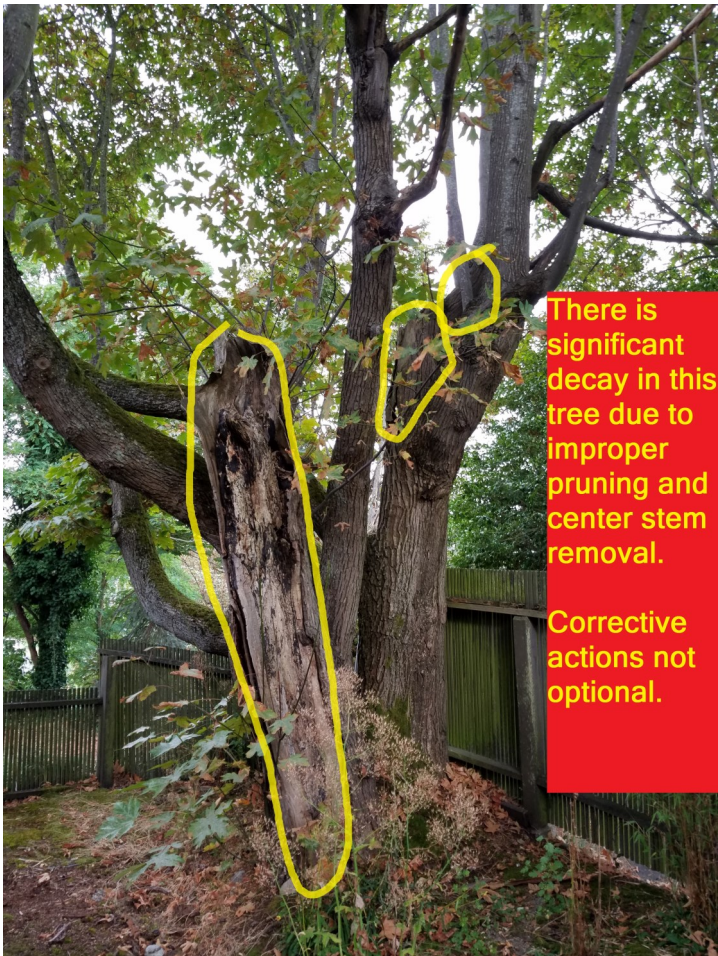
3.) *Acer macrophyllum* - bigleaf maple : 33" DBH, 45' Tall, 21' Drip Line .

Now Exceptional Diameter (Threshold 30")

The deformed structure of this tree makes accurate measurement at 54" from ground extremely difficult.

The advancing interior decay in this tree appears to have caused trunk swelling and bark expansion since last measurement 10 months ago - December 18, 2015

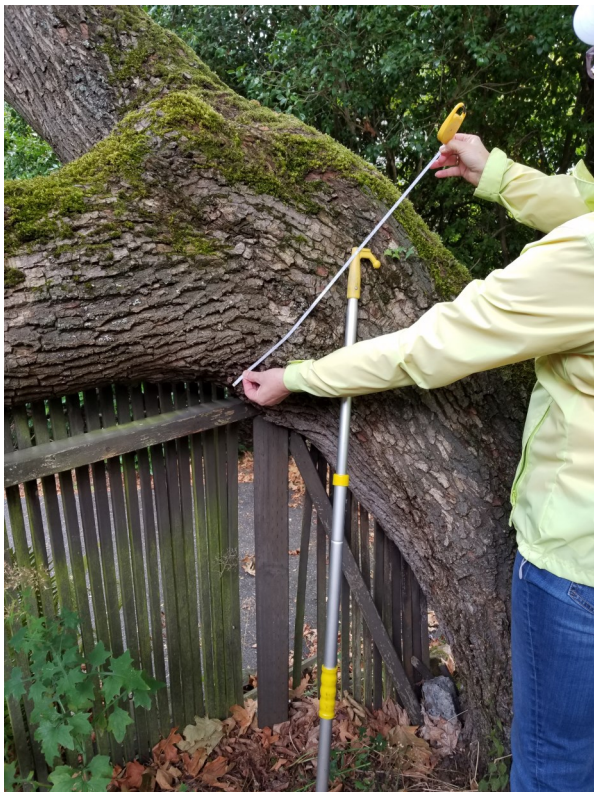
4.) *Acer macrophyllum* - bigleaf maple : 23" DBH, 40' Tall, 14' Drip line.

Not Exceptional (Threshold 30")

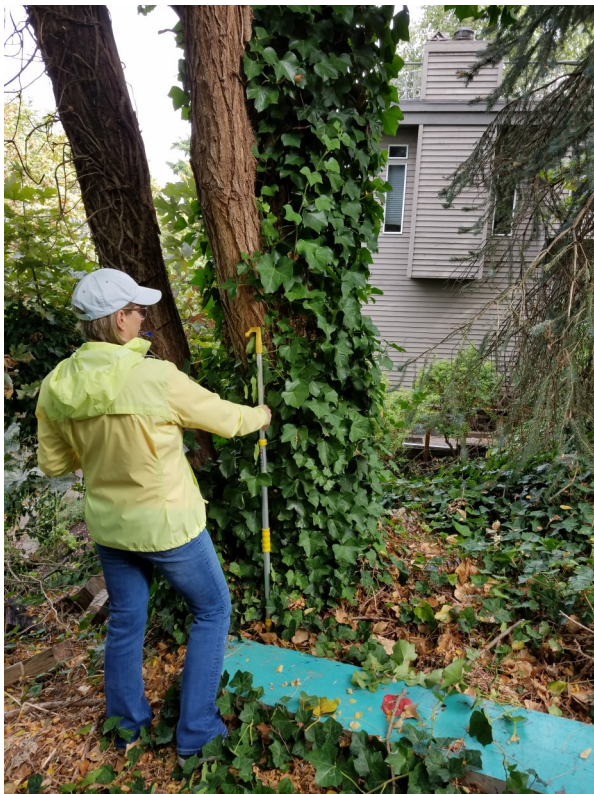
6.) *Robinia pseudoacacia* — black locust (Corrected species) : 22" DBH , 55' Tall, 30' Drip line.

Not Exceptional (Threshold 30".)

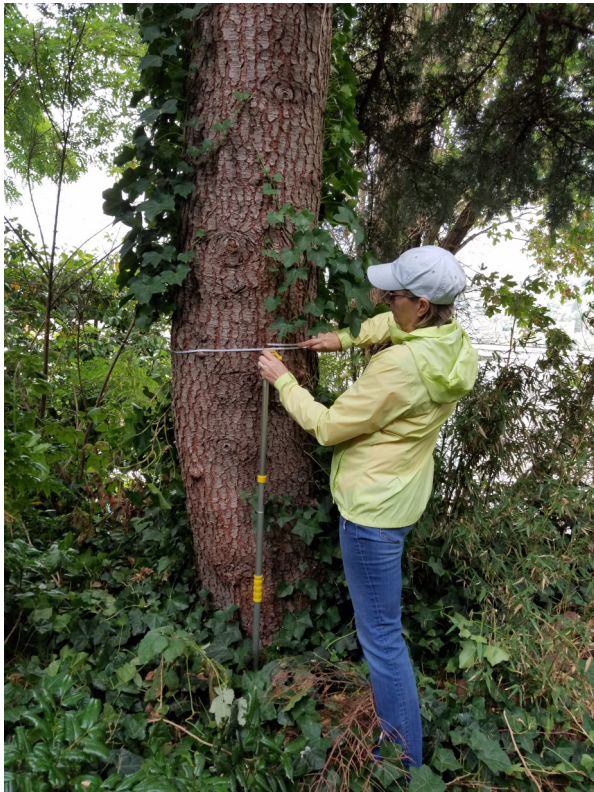
7.) ***Cedrus deodora***—**deodora cedar**: 22" DBH, 45' Tall, 30' Drip line.

Not Exceptional

(Threshold 30")

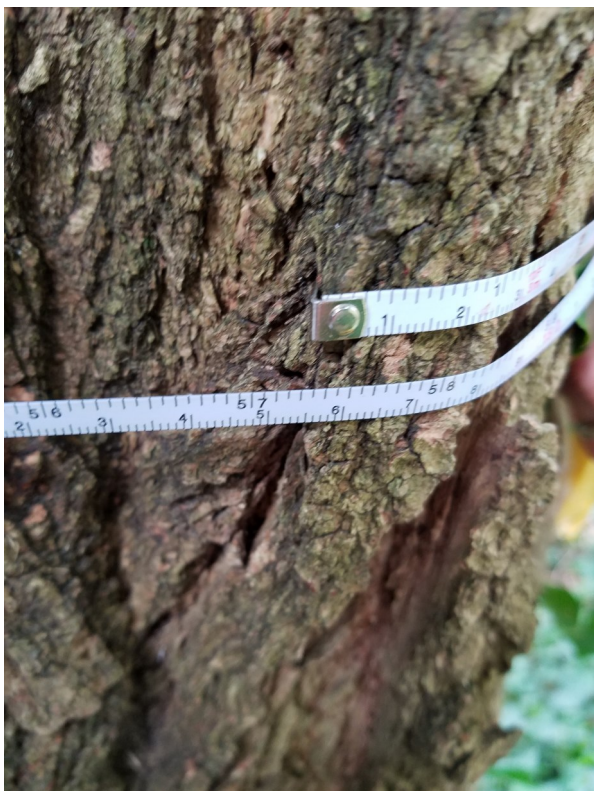
10.) ***Robinia pseudoacacia*** — **black locust** (Corrected species) : 18" DBH, 25' Tall, 18' Drip line.

Not Exceptional

(30" Threshold.)
